December 11, 2018 Landslide and 90-m Icy Tsunami in the Bureya Water Reservoir

Viacheslav Gusiakov and Alexey Makhinov

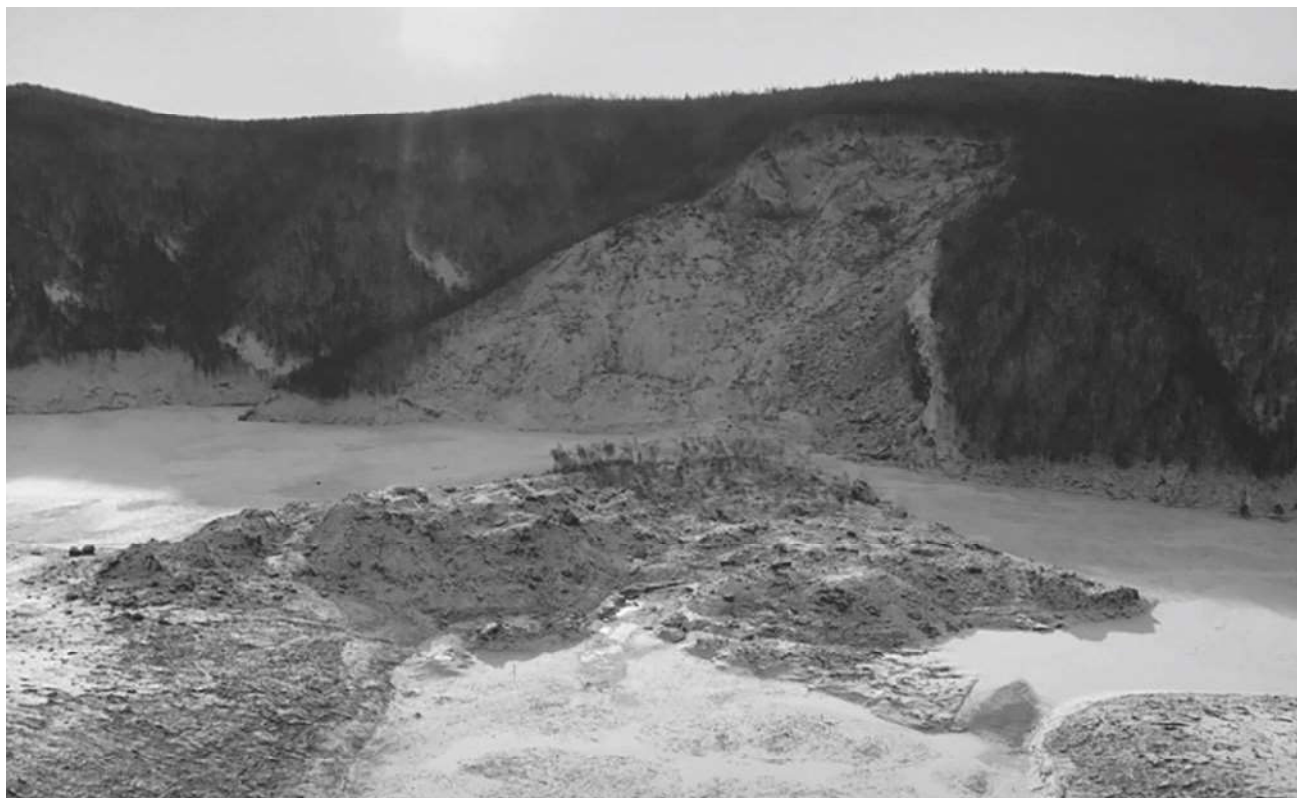
Fig. 1 General view of the landslide scar on the southern slope of the left bank and the landslide body blocking the river bed. Note the trees, remaining in inclined but standing position on the top of the rear part of

the landslide. Photo by A. Makhinov taken on 25.12.2018 from a helicopter MI-8

On December 11, 2018, at 14:48 of local time, a large (with an estimated volume up to 25 million cubic meters) landslide occurred on the left (southern) slope of the Bureya water reservoir (Russian Far East) (Fig. 1). The landslide occurred in the middle part of the reservoir where the river valley is oriented almost strictly from east to west. The Bureya river is the third-longest (after the Zeya and the Ussury rivers) tributary of the Amur river, the largest river in the Russian Far East. The Bureya HPP built in 2009 with its dam of 140 m high and 20.9 km³ water reservoir plays an important role in the Russian Far East electric supply system. It has installed capacity of 2.1 MW and produces up to 17% of electricity in the regional electric system. The landslide completely blocked the river bed and prevented the replenishment of the Bureya reservoir from a large part of its catchment area that created a federal-level emergency situation. In the deep (down to 70 m) water reservoir, the landslide generated a destructive tsunami-like wave whose impact on the banks was emphasized by a thick (up to 20 cm) ice cover.

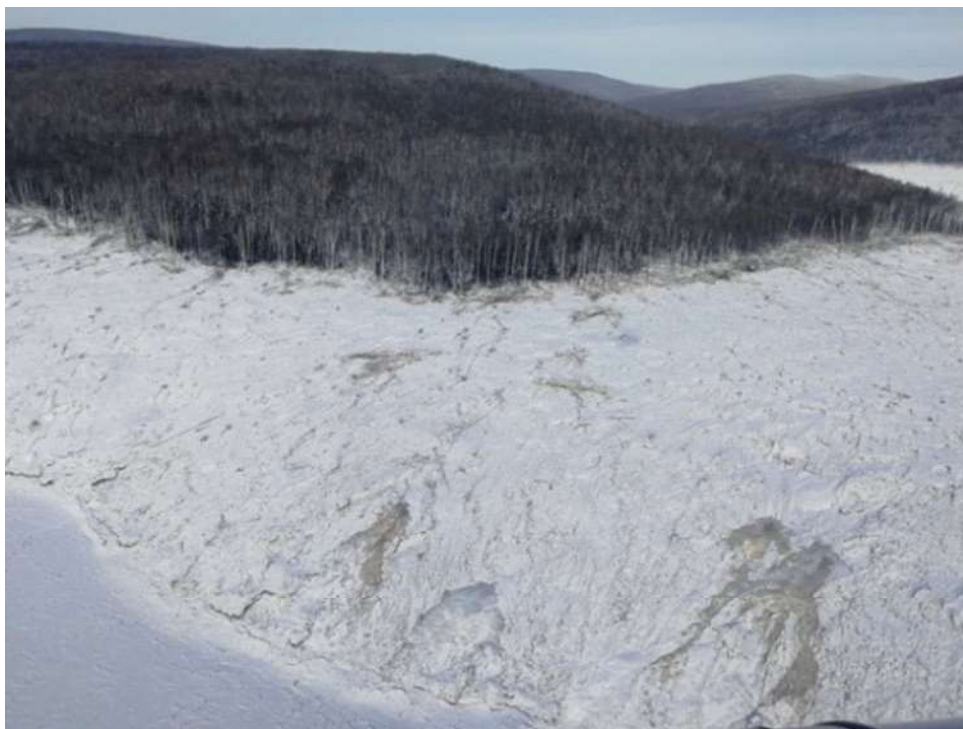
Fig. 2 The area on the right (northern) bank of the Bureya reservoir near the mouth of the Sredniy Sandar river. Note the evident trim line, below which vegetation and soil cover have been completely removed by the upslope water flow and the gullies produced on the steep coastal slope by backwash currents. Photo by A. Makhinov taken on 25.12.2018 from a helicopter MI-8

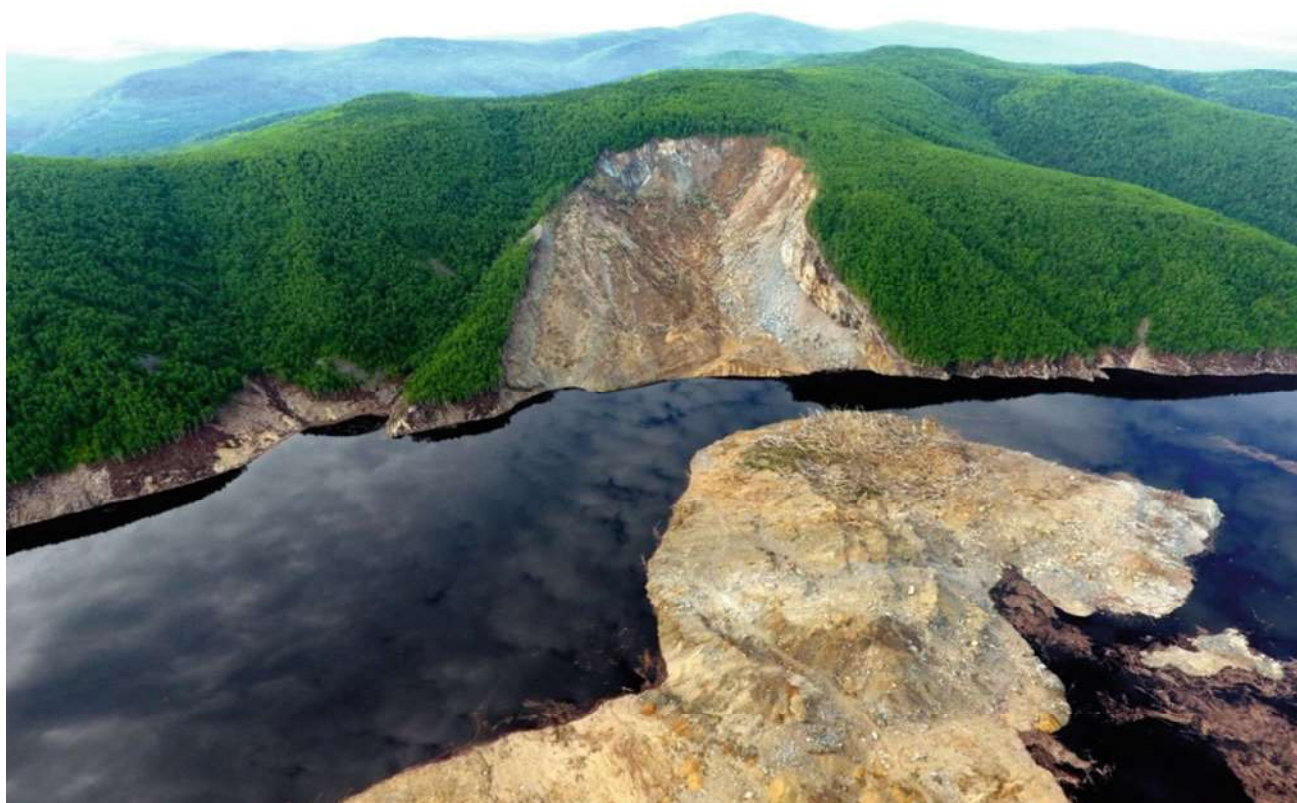
Fig. 3 General view of the landslide scar on the southern bank of the Bureya water reservoir and the body of the landslide with a passage, initially made in February 2019 and then extended by the spring flood

in April-May 2019. Photo by A. Ostroukhov taken from quadcopter “Fantom4” on June 19, 2019

The failure of the southern slope occurred at the elevation of ~550 m above the initial water level at the time of the event. The landslide's separation bowl is deeply cut into the slope and, being rectangular in plan, has a considerable size of about 600 m in length and 500 m in width (Fig. 3). Along the upper edge of the amphitheater there are several small blocks of rocks that are marked by gaping cracks and ready for displacement but remain in place. In the lower part of the amphitheater formed a thin cover of rock fragments of different sizes that continuously roll down from the exposed slope.

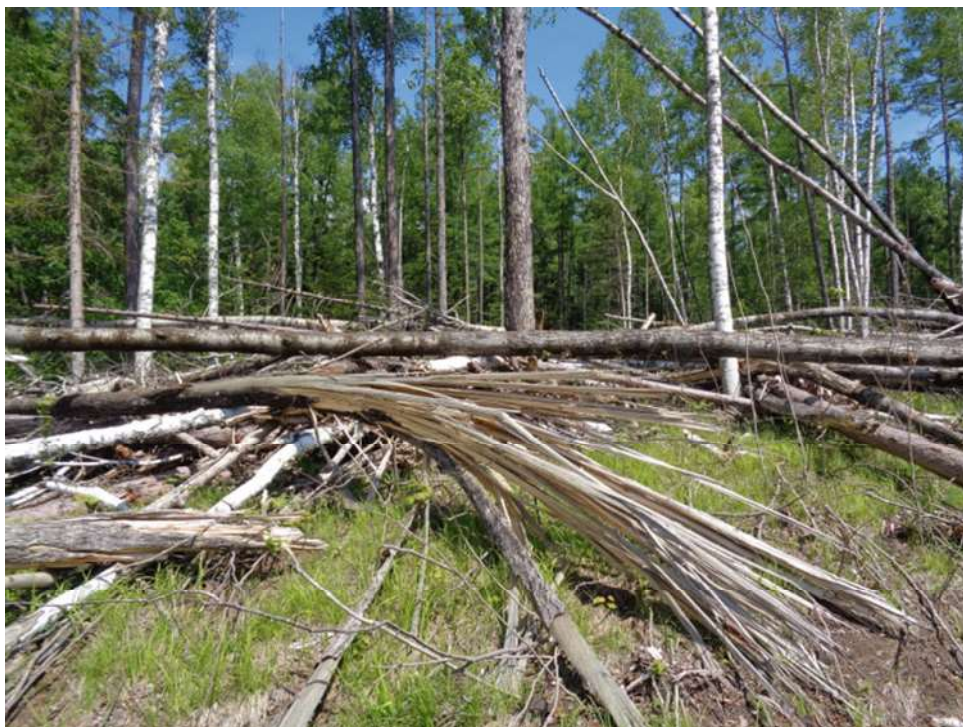
Fig. 5 Debris along the inundation limit formed by the cut and broken trees. Photo by V. Gusiakov

Along the large part of the trim line clearly visible on air photos and satellite images, the wave left the piles of broken and damaged trees (Fig. 5). Backwash currents produced deep (up to 1.0–1.5 m) gullies on the steep parts of the right (north) bank lying directly against the landslide (Fig. 6).

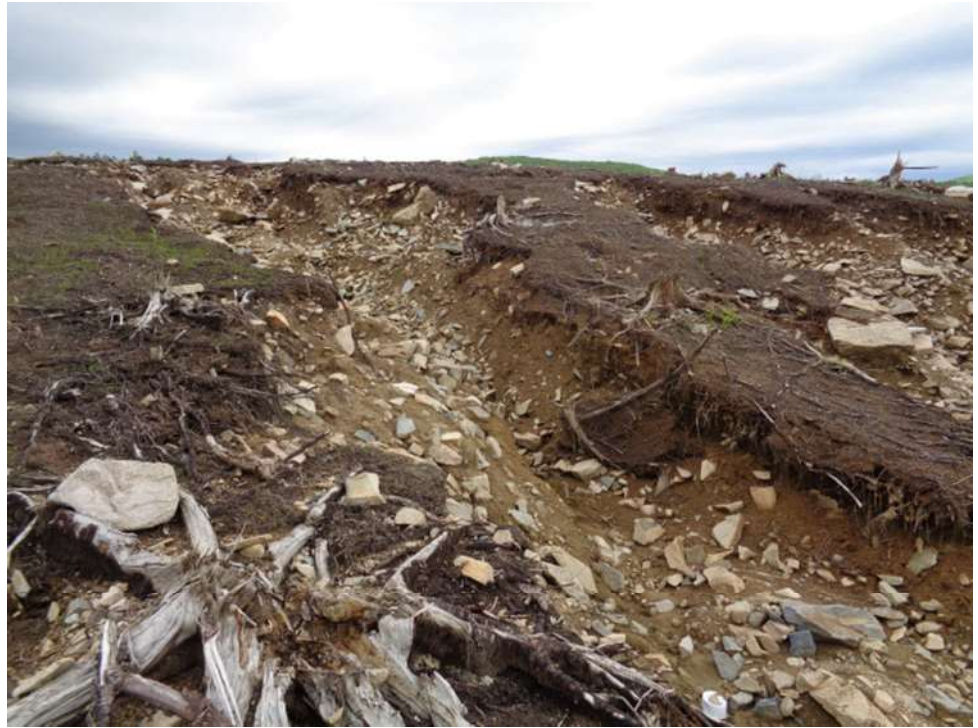
Fig. 6 Gullies on the opposite (right) bank of the Bureya river made by the backup wash currents. Photo by V.Gusiakov

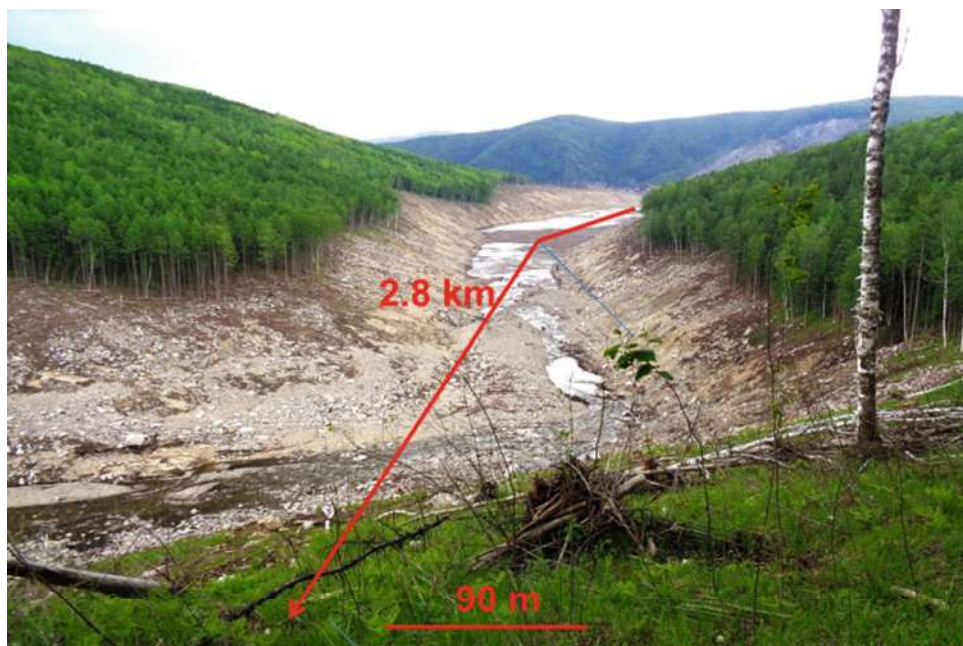
Fig. 8 Left bank of the Sredniy Sandar river. The place of the maximum run-up height (90 m above the initial water level) reached here at the distance about 2.8 km from the landslide. Photo by V. Gusiakov

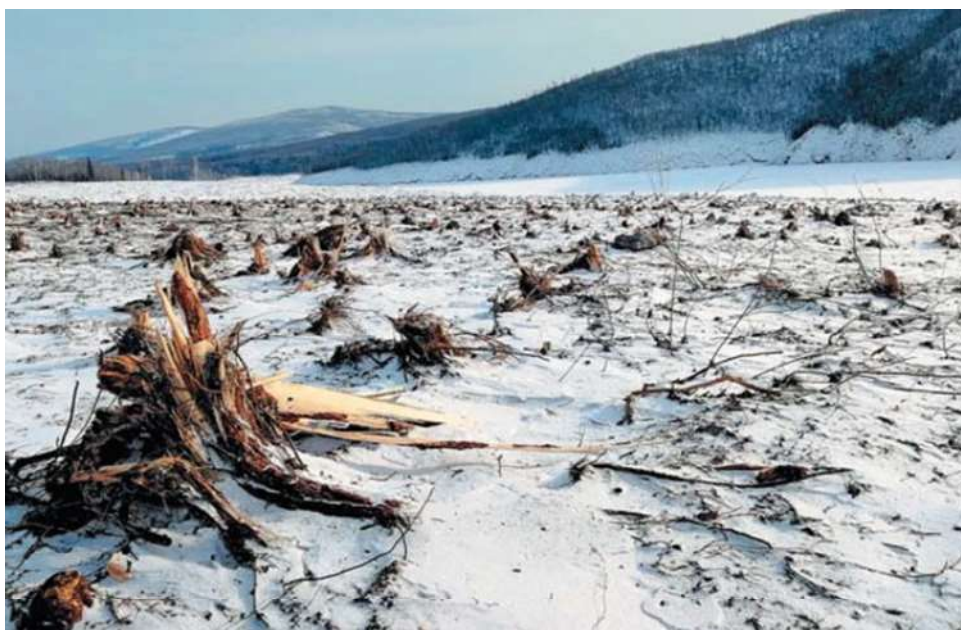
Fig. 9 Damaged stumps and exposed tree roots on the gentle coastal slope located directly opposite the landslide on the right (northern) bank of the Bureya River. Note the clearly marked trim line on the left (southern) bank of the reservoir. Photo by A. Makhinov taken on 25.12.2018

The gentle coastal slope on the right (northern) bank lying directly opposite the landslide suffered the strongest wave impact. The high velocity water flow completely removed both vegetation and soil leaving only damaged stumps and exposed tree roots on the place of dense forest that grew here earlier (Fig. 9) The maximum inundation level reached here 62 m with maximum horizontal flooding up to 650 m.
